## Property Inspection Report

Property address: 259 Acorn Ave.  
Eugene, Or. 97401

Inspection date: **Wednesday, July 13, 2016**

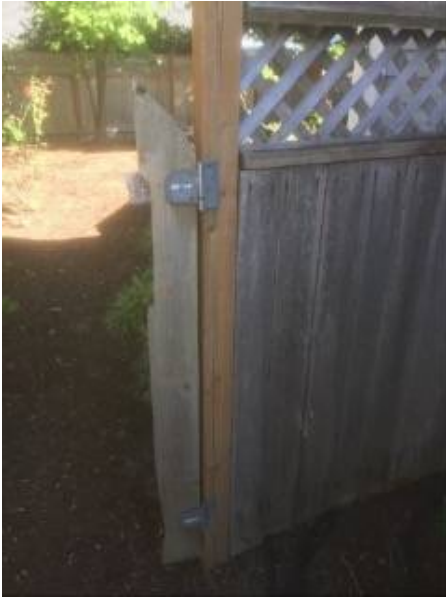
Photo 2-1

One or more fences and/or gates were damaged or deteriorated and need repair.

- The center gate on the west side of the house was missing.
- Some of the fencing boards and cross members were damaged by fungal rot and required repair.

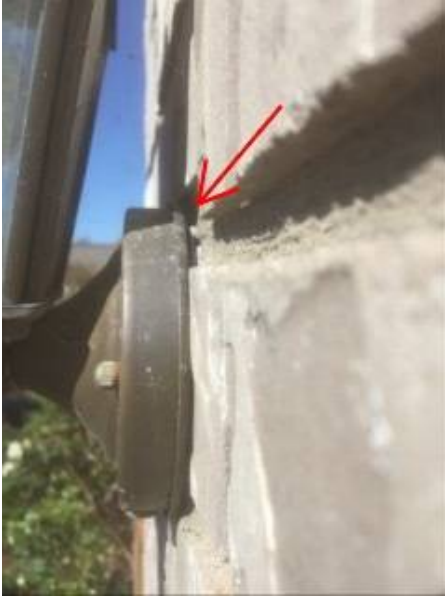
Photo 6-1

One or more wall-mounted exterior light fixtures had no caulk installed above the back plate. Water can enter the space behind the back plate and contact wiring. This is a potential shock hazard.

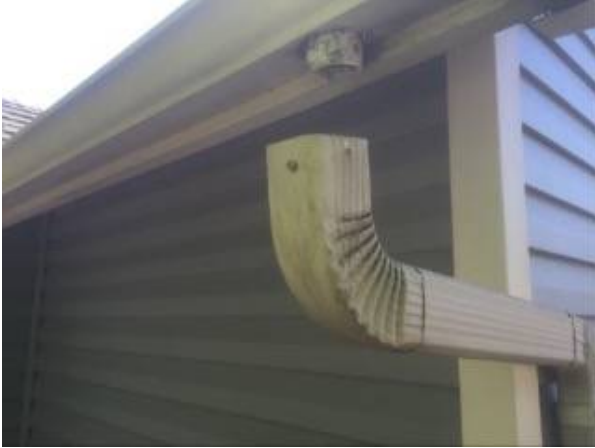
Photo 7-1

One or more downspouts or elbows were loose or detached. Rainwater can come in contact with the building exterior or accumulate around the foundation as a result. This is a conducive condition for wood-destroying organisms.

Repaired- the downspout was re-attached to the gutter

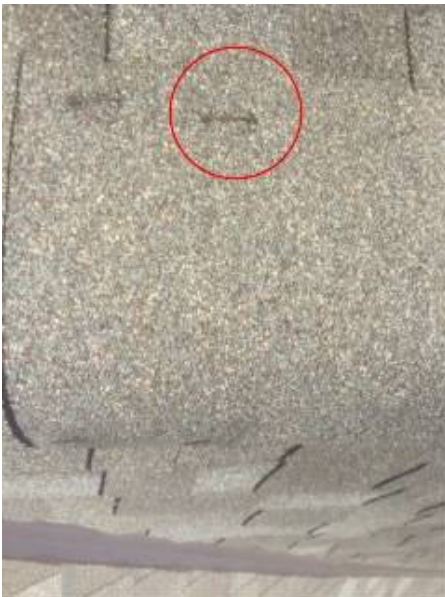
Photo 8-1

Exposed fasteners for rooftop items such as dish antennas, roof shingles, flashings, guide wires or masts were missing sealant or had substandard sealant. Leaks can occur as a result. This is a conducive condition for wood-destroying organisms.

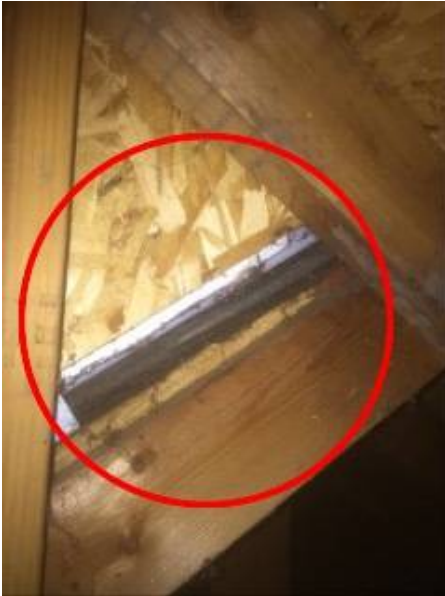
Photo 9-1

The trim for the vinyl siding was too close to the roof shingles along the roof to wall intersection above the garage. When I was inspecting the attic I noticed that the roof to wall flashing at this location was a single piece of flashing, not the industry standard step shingle application. In addition to this flashing being a single piece, it was not installed full length. It was approximately 10" short at the top and day light was visible.

Recommend this flashing be replaced with step shingles and the trim for the vinyl siding be reinstalled 1-2" above the roof shingles.

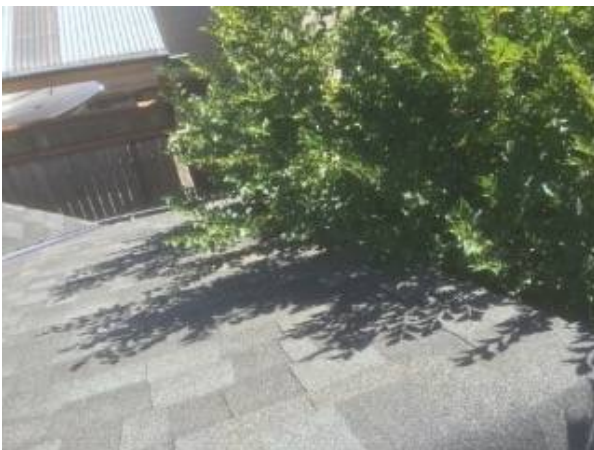
Photo 10-1

Vegetation such as trees, shrubs, and/or vines overhung the roof surface or were in contact with the roof edge. Organic debris such as leaves or needles are likely to accumulate in gutters and on the roof surface. Gutters can overflow and cause water to come in contact with the building exterior or water can accumulate around the foundation. This is a conducive condition for wood-destroying organisms. Vegetation in contact with the roof can damage the roof surface and/or the roof drainage system. Recommend pruning vegetation so as to not be in contact with the roof and to not overhang the roof surface. If vegetation is too tall then it should be pruned at least 10 feet above the roof surface.

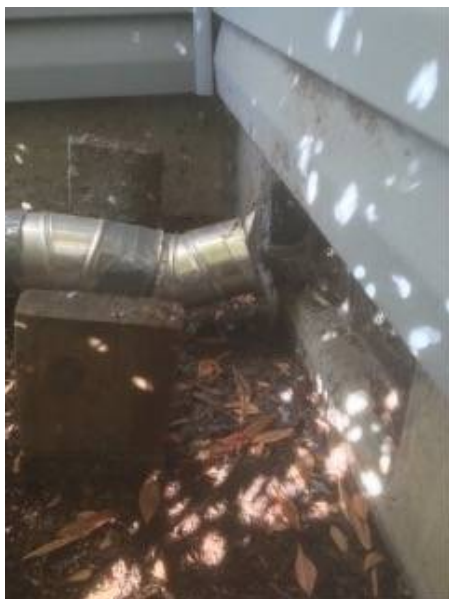
Photo 11-1

The venting for the clothes dryer was disconnected at the foundation wall. This ducting should be repaired so the moist air and lint that is produced by the clothes dryer is properly vented out of the crawl space.

Repaired- the dryer vent/hood was reconnected to the new ducting.

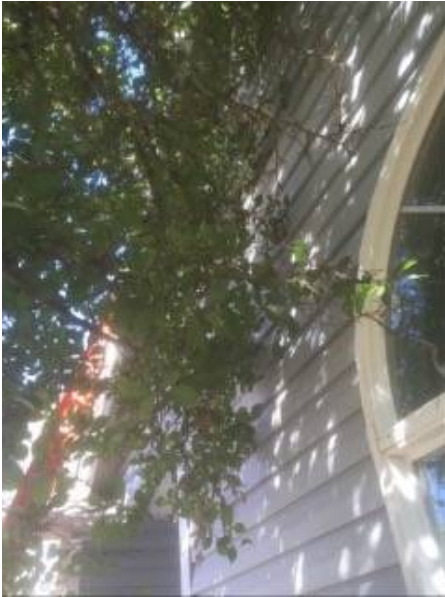
Photo 12-1

Vegetation such as trees, shrubs and/or vines was in contact with or close to the building exterior. Vegetation can serve as a pathway for wood-destroying insects and can retain moisture against the exterior after it rains. This is a conducive condition for wood-destroying organisms. Recommend pruning, moving or removing vegetation as necessary to maintain at least 6 inches of space between it and the building exterior. A 1-foot clearance is better.

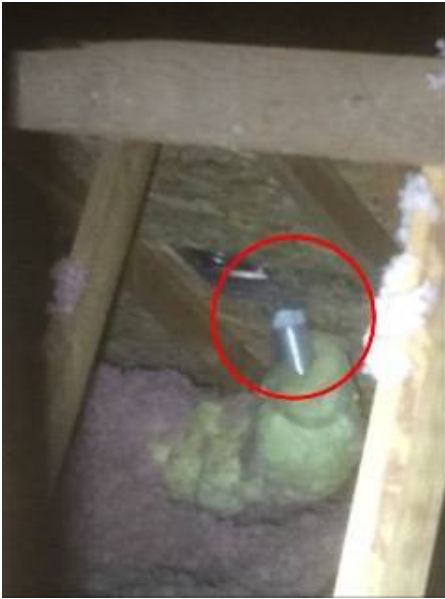
Photo 15-1

15) 🛠️✅💧 One or more exhaust ducts (e.g. bathroom fan, clothes dryer) in the attic have come apart, were loose or have fallen down. This can result in increased moisture levels inside the structure and is a conducive condition for wood-destroying organisms.

Repaired- the ducting was not re-positioned at the time of the re-inspection but I was able to make this correction while I was on site.

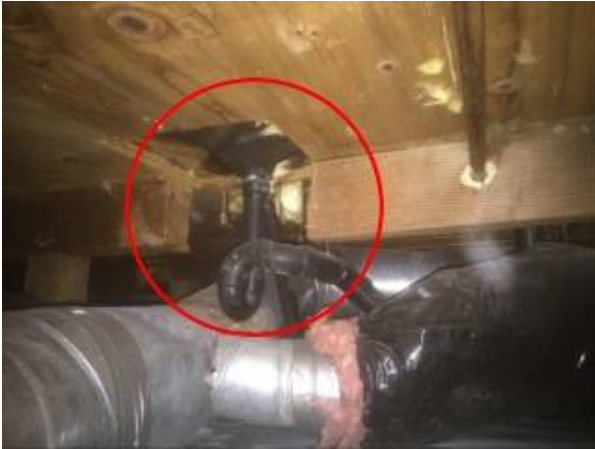
Photo 16-1

The floor beam under the shower in the guest bathroom had been cut in half and no support post had been added to support the cut end of this post. Recommend a licensed contractor be hired to evaluate and repair as required.

Repaired- a new pier block and post were added to the beam on the right side.

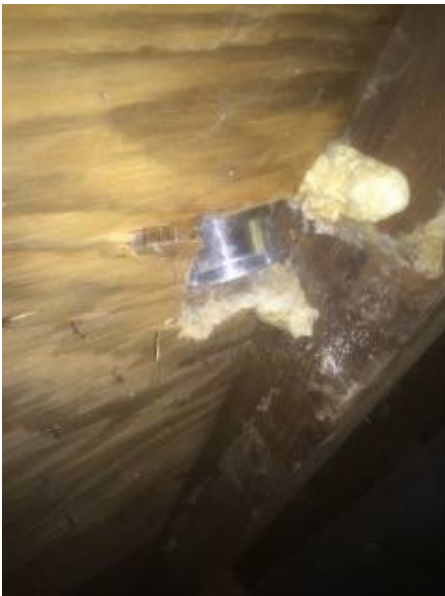
Photo 17-1

17 🛠️✅💧 - It appeared the ducting for the clothes dryer in the crawl space was removed. The duct penetrates the floor and there was no ducting connecting the duct at the floor line to the exterior of the house.

Repaired- a new dryer duct was installed

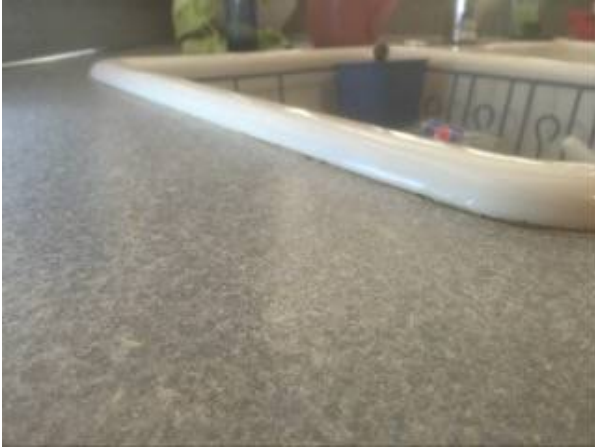
Photo 24-1

Gaps, no caulk, or substandard caulking were found around the sink. Water may penetrate these areas and cause damage.

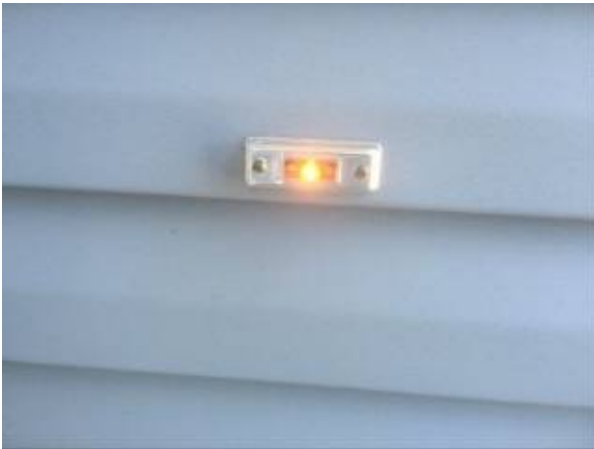
Photo 30-1

The front door's doorbell button was damaged.

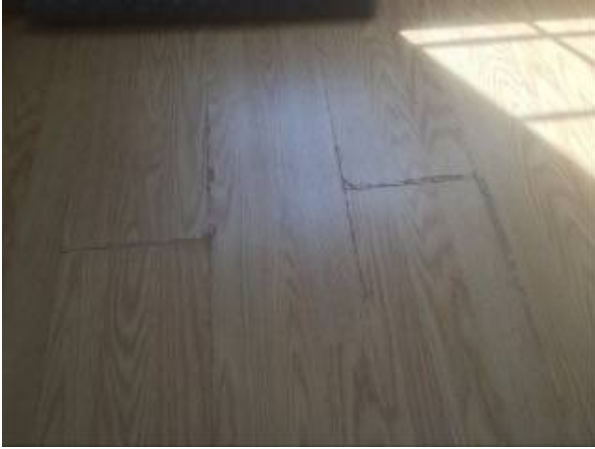
Photo 35-1

The laminate flooring was damaged in some locations. The damaged pieces of flooring should be replaced.

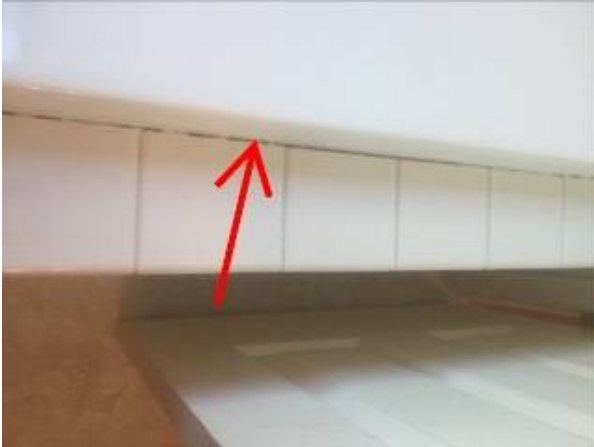
Photo 40-1

40) 🛠️💧 Gaps, no caulk, or substandard caulking were found between the bathtub and the floor and/or Tub/tile/surround. Water may penetrate these areas and cause damage.

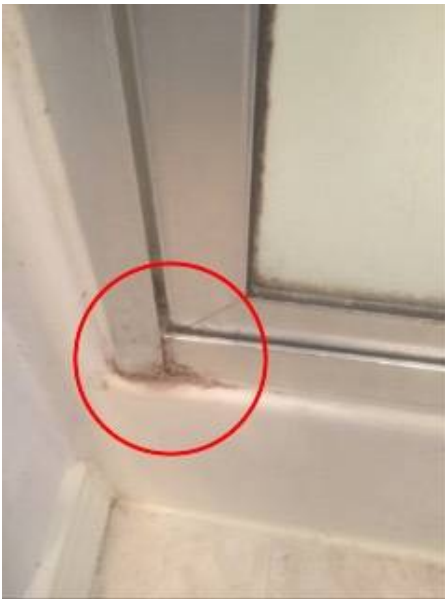
Photo 41-1

41) 🛠️💧 The shower door frame appeared to be leaking between the shower and frame or between the metal track pieces. Recommend repairing this leak so damage does not occur to the flooring/walls.

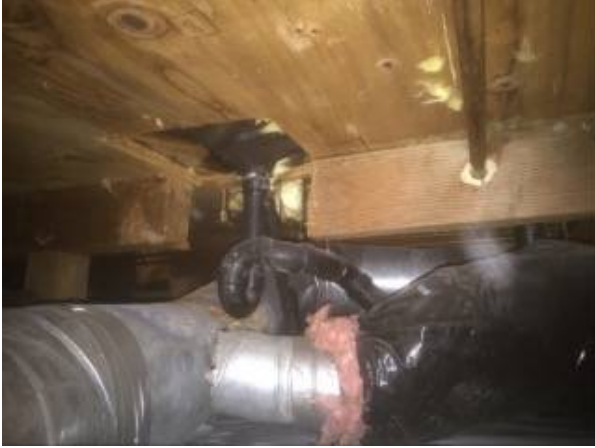
Photo 44-1

The crushed ducting was not repaired. The joint that was separated had been re-sealed.

Note- The small area of the crushed ducting most likely will not alter the air flow enough to affect the performance of the system. If you are going to receive copies of the repair invoices maybe the HVAC contractor made a note about this issue for your records

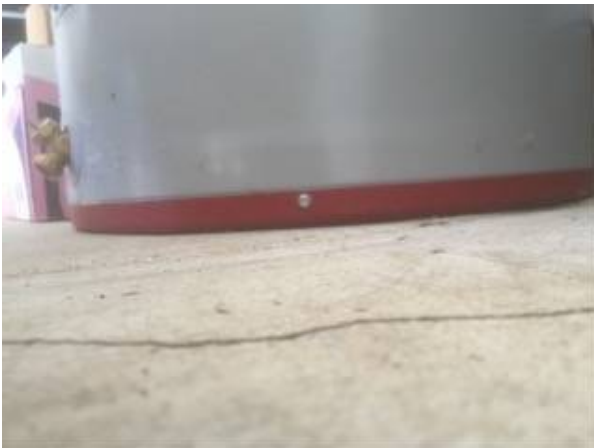
Photo 48-1

The water heater was installed in an unheated space on a concrete floor and was not resting on an insulated pad. The bottom of the casing is likely to rust, and energy efficiency may be reduced.

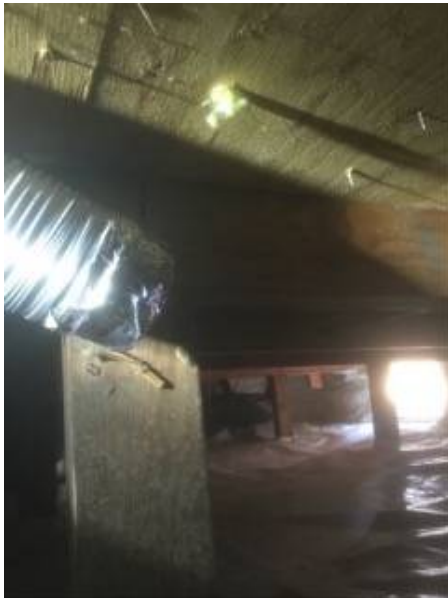
Photo 54-1

Due to the sealing off of the crawl space the make up air vent for the fireplace may not have access to the required fresh air. Recommend reviewing the issue with a licensed fireplace contractor to verify it this duct will need to be extended to the exterior of the house.

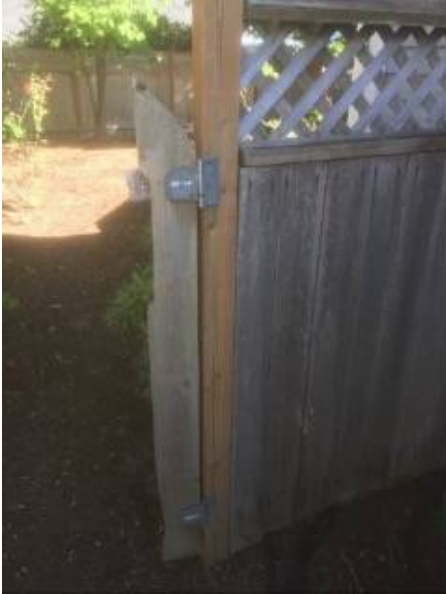
Photo 2-1

- The center gate on the west side of the house was missing.
- Some of the fencing boards and cross members were damaged by fungal rot and required repair.

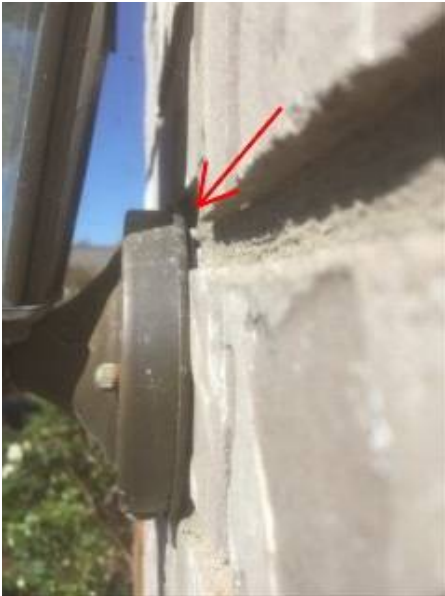
Photo 6-1

- One or more wall-mounted exterior light fixtures had no caulk installed above the back plate. Water can enter the space behind the back plate and contact wiring. This is a potential shock hazard.

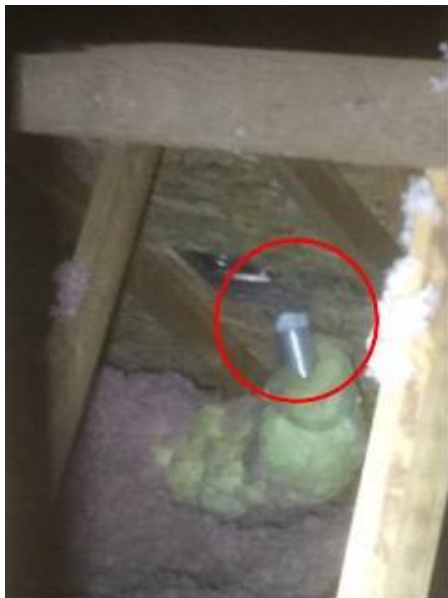
Photo 15-1

15 🛠️✅💧 - One or more exhaust ducts (e.g. bathroom fan, clothes dryer) in the attic have come apart, were loose or have fallen down. This can result in increased moisture levels inside the structure and is a conducive condition for wood-destroying organisms.

Repaired- the ducting was not re-positioned at the time of the re-inspection but I was able to make this correction while I was on site.

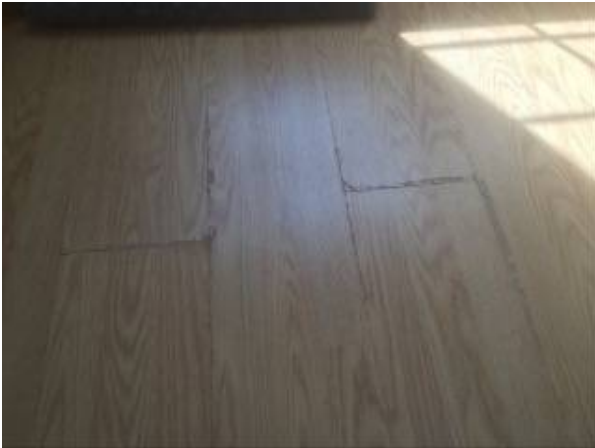
Photo 35-1

- The laminate flooring was damaged in some locations. The damaged pieces of flooring should be replaced.

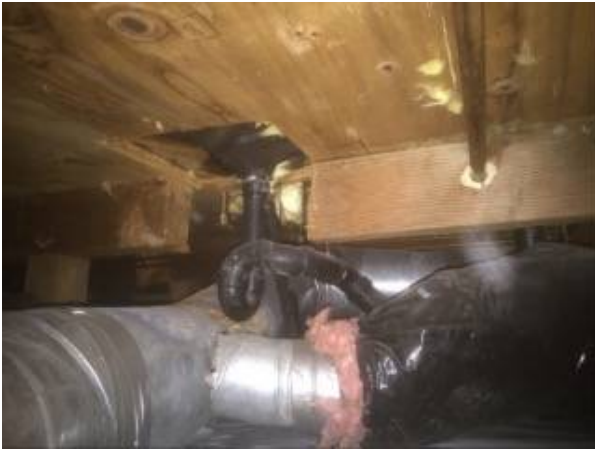
Photo 44-1

The crushed ducting was not repaired. The joint that was separated had been re-sealed.

Note- The small area of the crushed ducting most likely will not alter the air flow enough to affect the performance of the system. If you are going to receive copies of the repair invoices maybe the HVAC contractor made a note about this issue for your records

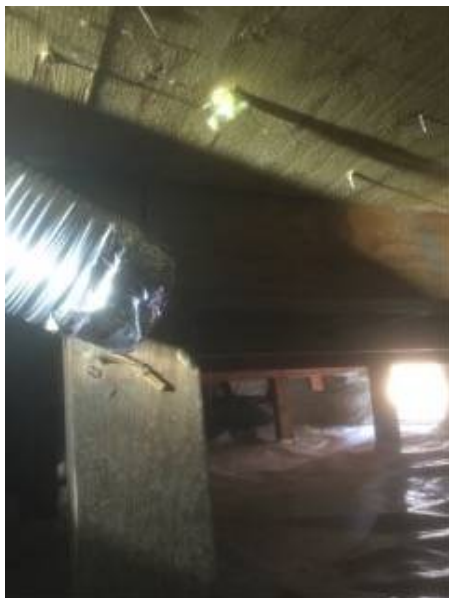
Photo 54-1

- Due to the sealing off of the crawl space the make up air vent for the fireplace may not have access to the required fresh air. Recommend reviewing the issue with a licensed fireplace contractor to verify it this duct will need to be extended to the exterior of the house.
